COLUMBIA

ACCIDENT INVESTIGATION REPORT

REPORT VOLUME I
AUGUST 2003

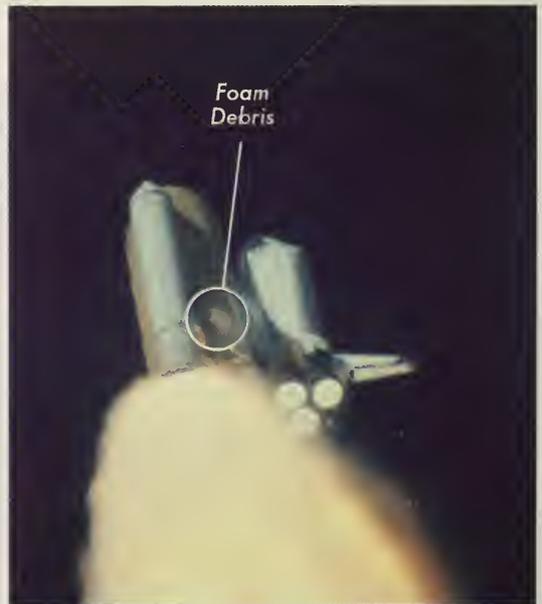
Figure 2.3-2. A shower of foam debris after the impact on *Columbia's* left wing. The event was not observed in real time.

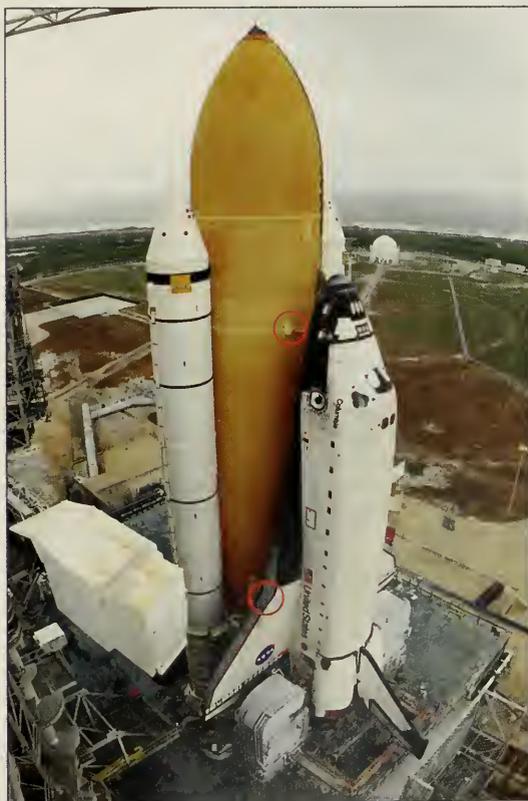
Figure 3.1-1. Columbia sitting at Launch Complex 39-A. The upper circle shows the left bipod (-Y) ramp on the forward attach point, while the lower circle is around RCC panel 8-left.

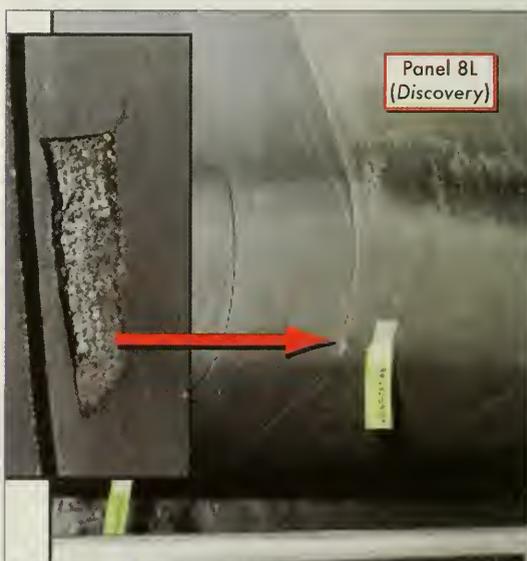
Figure 3.3-5. RCC panel 8-left from *Discovery* had to be scrapped after STS-103 because of the damage shown here.

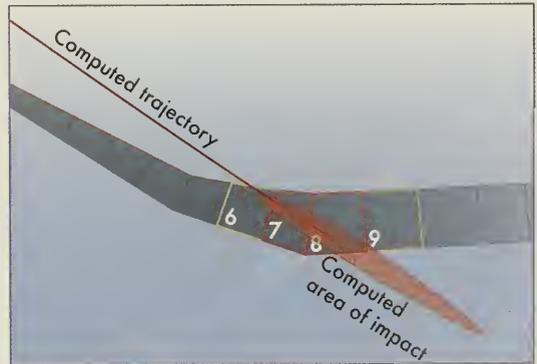
Figure 3.4-3: The best estimate of the site of impact by the center of the foam.

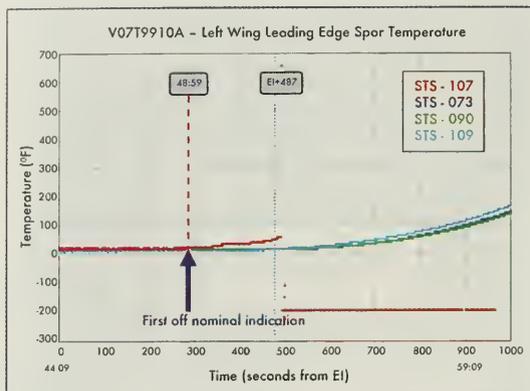
Figure 3.6-4. This temperature thermocouple (Sensor 2) was mounted on the outside of the wing leading edge spar behind the insulation that protects the spar from radiated heat from the RCC panels. It clearly showed an off-nominal trend early in the re-entry sequence and began to show an increase in temperature much earlier than the temperature sensor behind the spar.

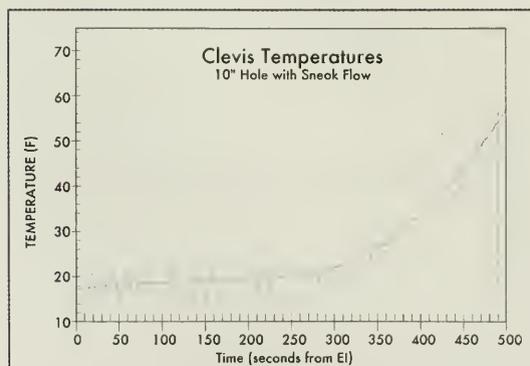
Figure 3.6-5. The analysis of the effect of a 10-inch hole in RCC panel 8 on Sensor 2 from EI to EI+500 seconds. The jagged line shows the actual flight data readings and the smooth line the calculated result for a 10-inch hole with some sneak flow of superheated air behind the spar insulation.

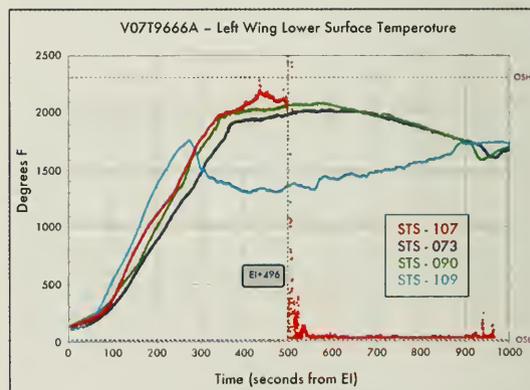
Figure 3.6-6. As early as EI+370, Sensor 3 began reading significantly higher than on previous flights. Since this sensor was located in a thermal tile on the lower surface of the left wing, its temperatures are much higher than those for the other sensors.

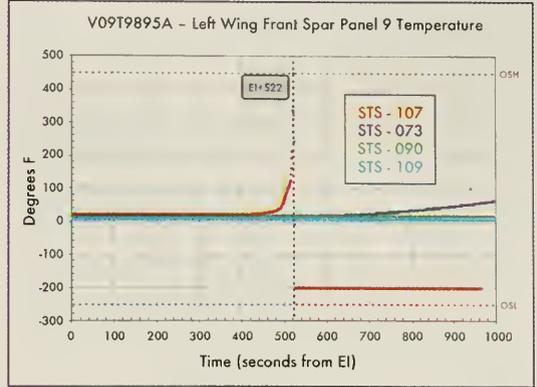
Figure 3.6-7. Sensor 4 also began reading significantly higher than previous flights before it fell off-scale low. The relatively late reaction of this sensor compared to Sensor 2, clearly indicated that superheated air started on the outside of the wing leading edge spar and then moved into the mid-wing after the spar was burned through. Note that immediately before the sensor (or the wire) fails, the temperature is at 450 degrees Fahrenheit and climbing rapidly. It was the only temperature sensor that showed this pattern.

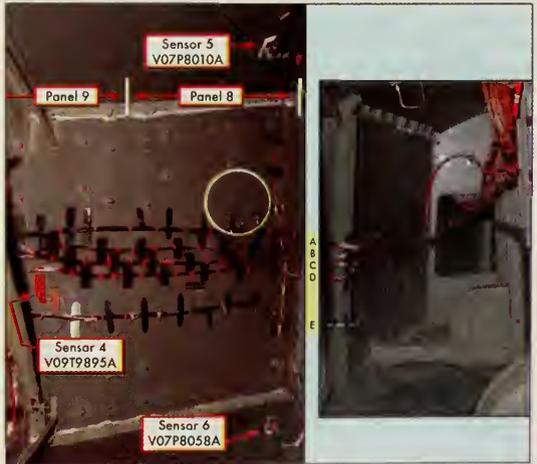
Figure 3.6-8. The left photo above shows the wiring runs on the backside of the wing leading edge behind RCC panel 8 – the circle marks the most likely area where the burn through of the wing leading edge spar initially occurred at EI+487 seconds. The right photo shows the wire bundles as they continue forward behind RCC panels 7 and 6. The major cable bundles in the upper right of the right photo carried the majority of the sensor data inside the wing. As these bundles were burned, controllers on the ground began seeing off-nominal sensor indications.

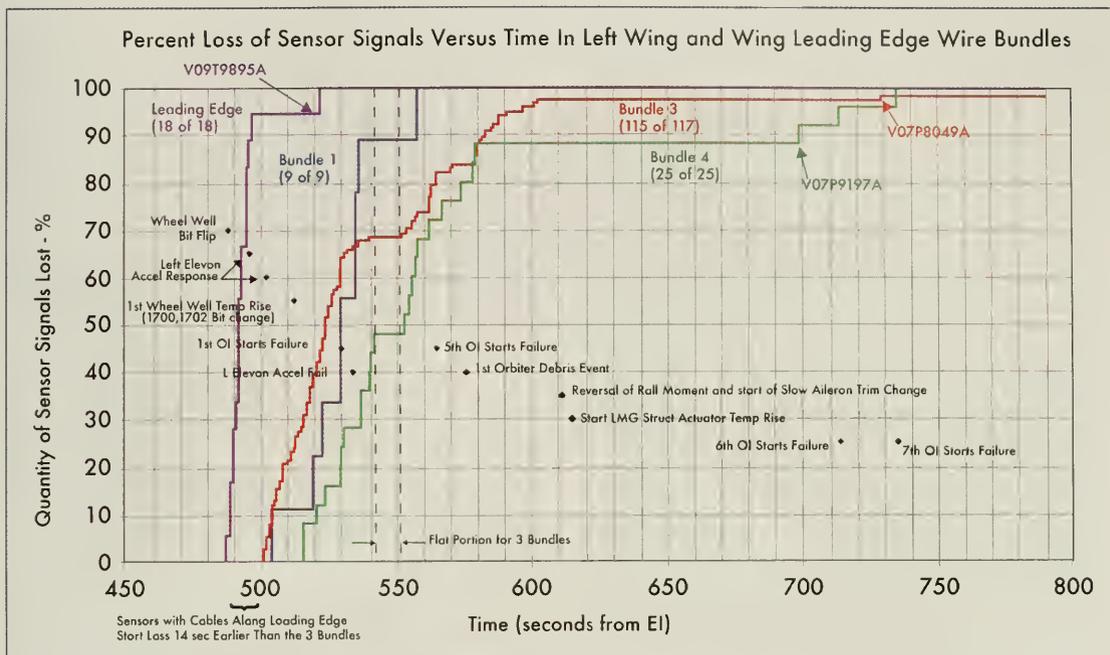
Figure 3.6-10. This chart shows how rapidly the wire bundles in the left wing were destroyed. Over 70 percent of the sensor wires in the wiring bundles burned through in under a minute. The black diamonds show the times of significant timeline sensor events.

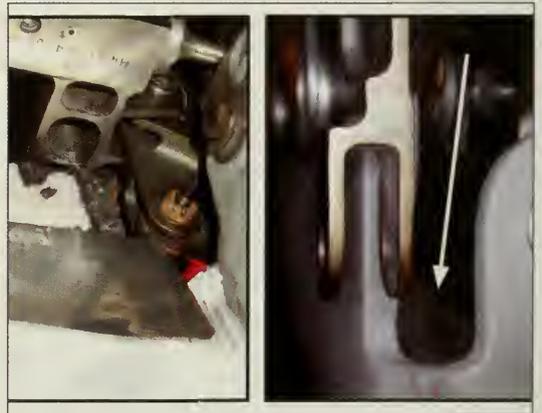
Figure 3.7-2. Each RCC panel has a U-shaped slot (see arrow) in the back of the panel. Once superheated air entered the breach in RCC panel 8, some of that superheated air went through this slot and caused substantial damage to the Thermal Protection System tiles behind this area.

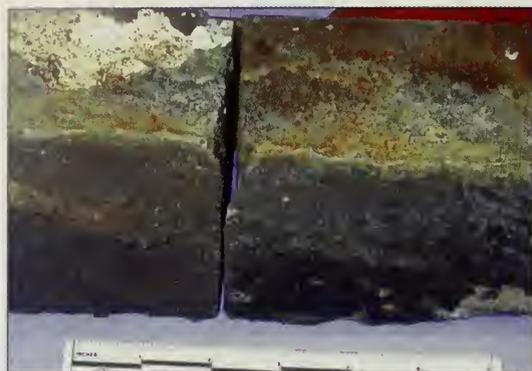
Figure 3.7-3. Superheated airflow caused erosion in tiles around the RCC panel 8 and 9 interface. The tiles shown are from behind the area where the superheated air exited from the slot in Figure 3.7-2. These tiles showed much greater thermal damage than other tiles in this area and chemical analysis showed the presence of metals only found in wing leading edge components.

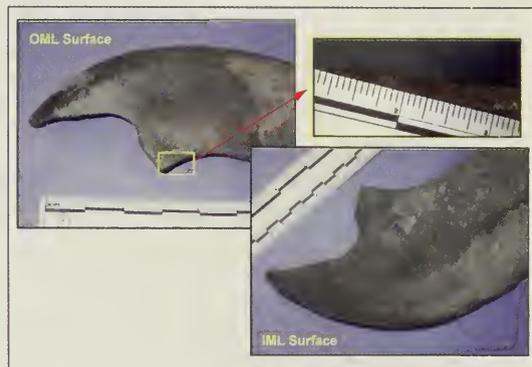
Figure 3.7-4. The outboard rib of panel 8 and the inboard rib of panel 9 showed signs of extreme heating and erosion. RCC erosion of this magnitude was not observed in any other location on the Orbiter.

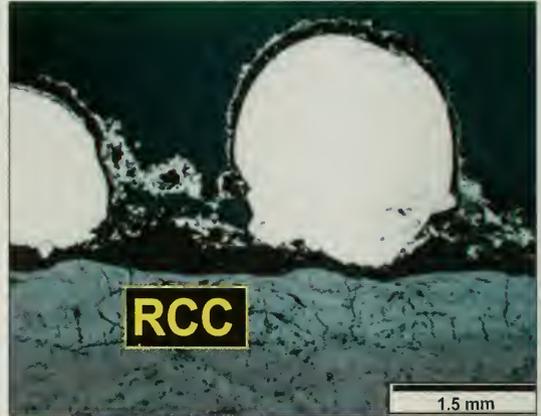
Figure 3.7-8. Spheroids of Inconel 718 and Cerachrome were deposited directly on the surface of RCC panel 8-left. This slag deposit pattern was not seen on any other RCC panels.

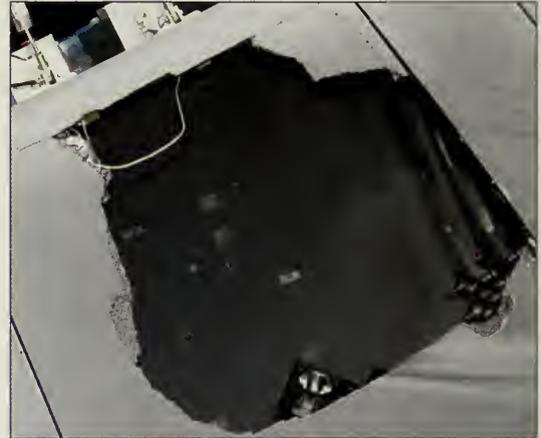
Figure 3.8-9. The large impact hole in Panel 8 from the final test.

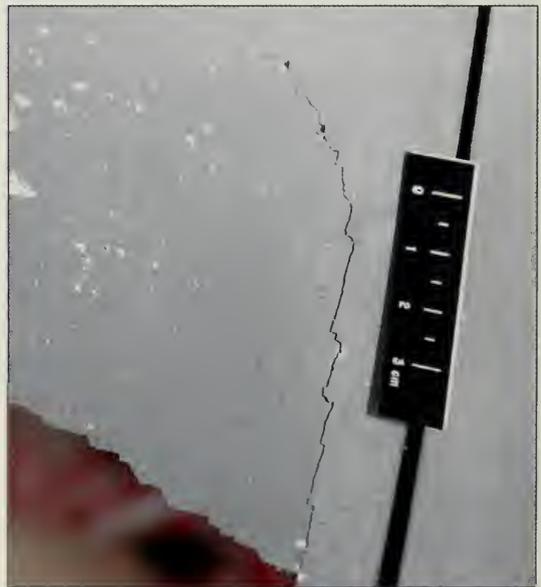
Figure 3.8-10. Numerous cracks were also noted in RCC Panel 8.

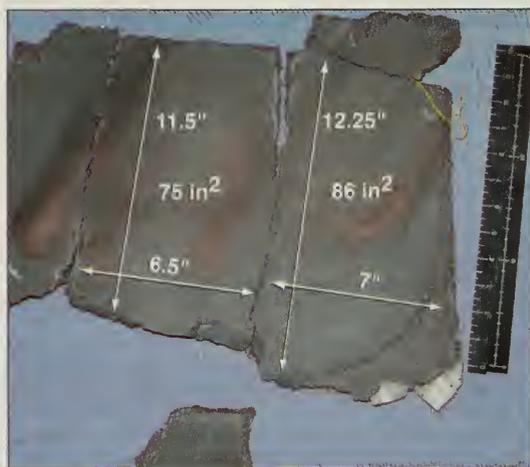
Figure 3.8-11. Three large pieces of debris from the panel face sheet were lodged within the hollow area behind the RCC panel.

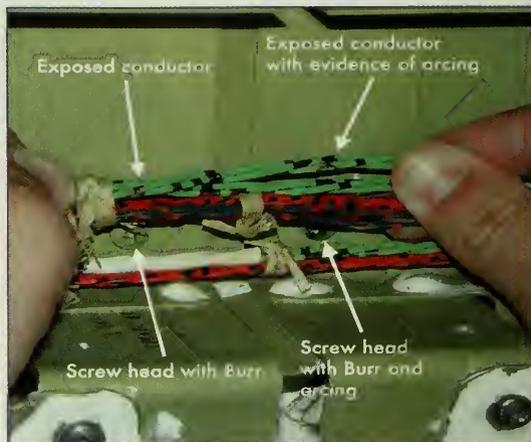
Figure 4.2-2. Arc tracking damage in Kapton wiring.

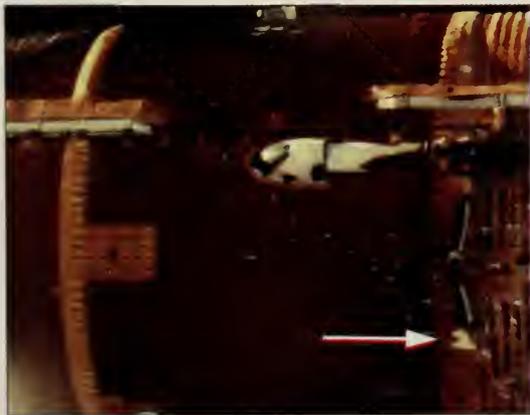
Figure 6.1-2. The first known instance of bipod ramp shedding occurred on STS-7 which was launched on June 18, 1983.

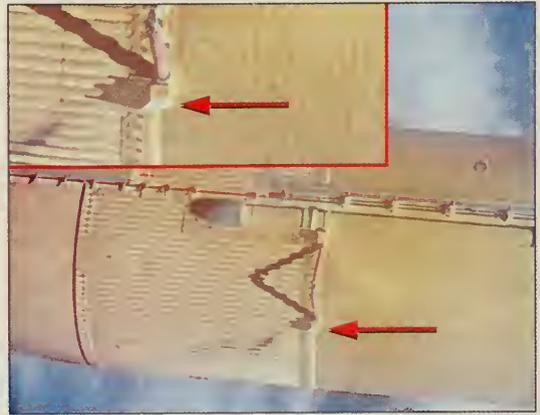
Figure 6.1-3. Only three months before the final launch of Columbia, the bipod ramp foam had come off during STS-112.
